BUILDING PERFORMANCE ASSESSMENT TEAM

Hurricane Fran in North Carolina

OBSERVATIONS,
RECOMMENDATIONS, AND
TECHNICAL GUIDANCE

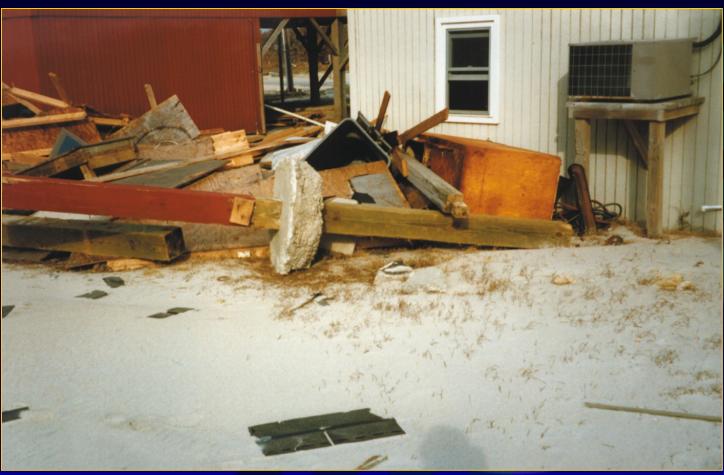
Erosion

- Affected oceanfront buildings
- Lowered beach profile 2 to 3 feet
- Lowered grade 4 to 6 feet below buildings
- Exacerbated by previous effects of Bertha

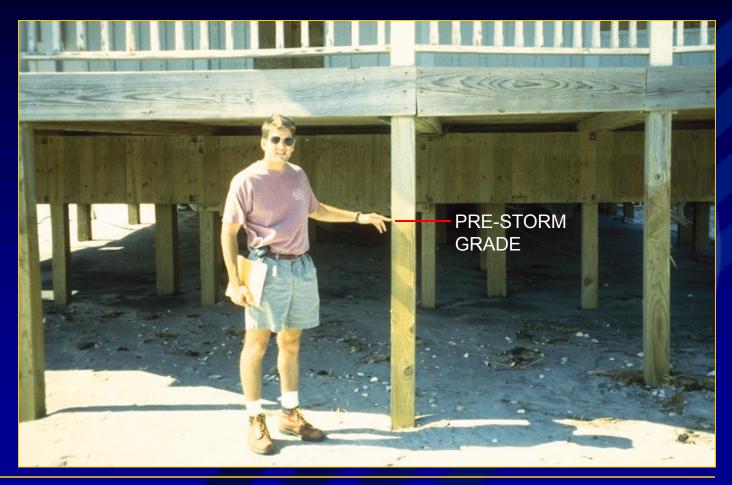
- Localized Scour
 - Affected oceanfront and landward buildings
 - Depth of scour = 1 to 1.5 times diameter or width of vertical member

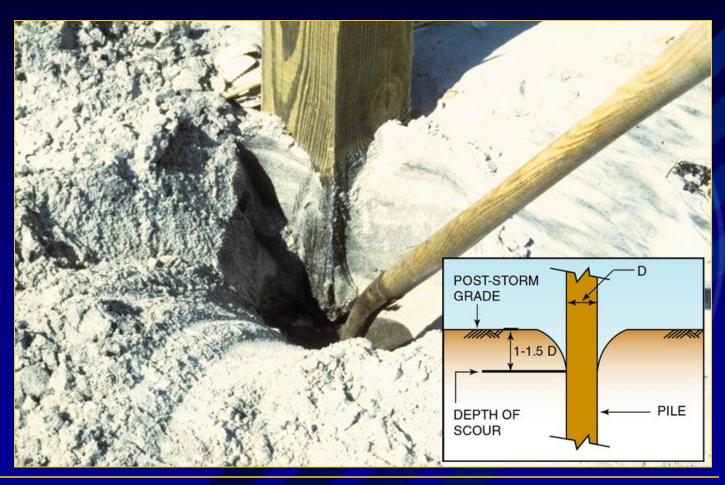
- Erosion Plus Localized Scour
 - Completely exposed, or reduced embedment depth of foundations
 - Resulted in collapse of over 100 oceanfront buildings
 - Resulted in many other buildings leaning

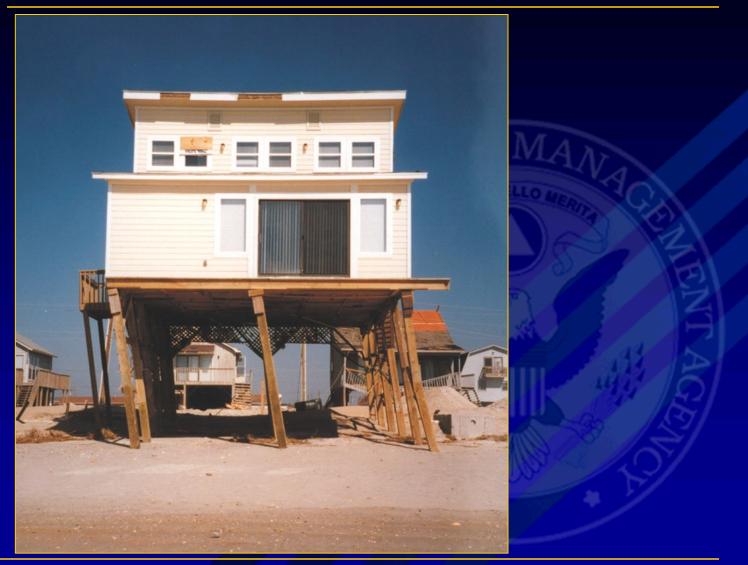
- State Building Code Embedment Requirements for Main Structure Pilings
 - Pre-1986 8 feet below grade for all structures
 - Post-1985 16 feet below grade or -5 feet m.s.l., whichever is shallower, for structures in erosion-prone areas

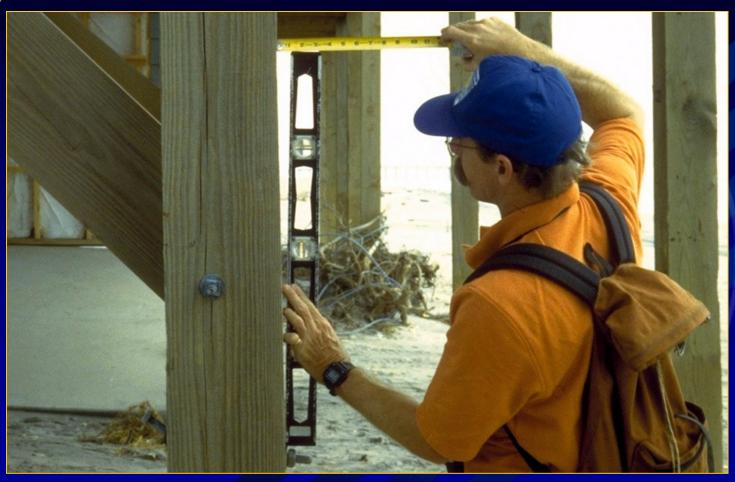
- Effect of Federal and State Requirements
 - Buildings that met CAMA,1986 State Building Code, and NFIP requirements outperformed all others
 - Post-Fran piling embedment depth study conducted on Topsail Island by FEMA contractor indicated value of deeper embedment requirement of 1986 State Code

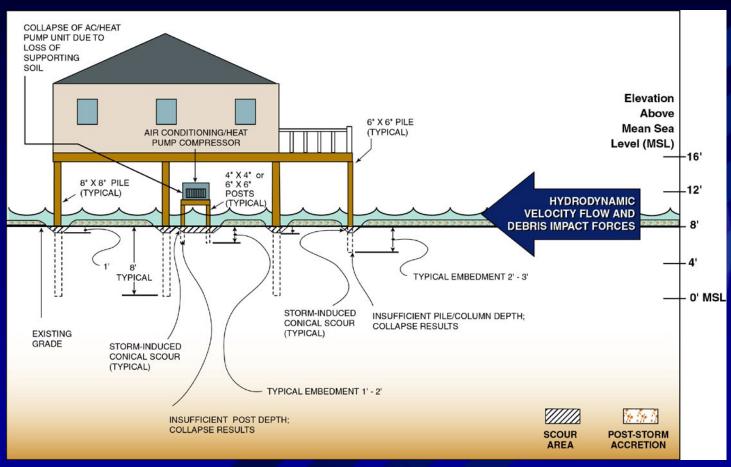
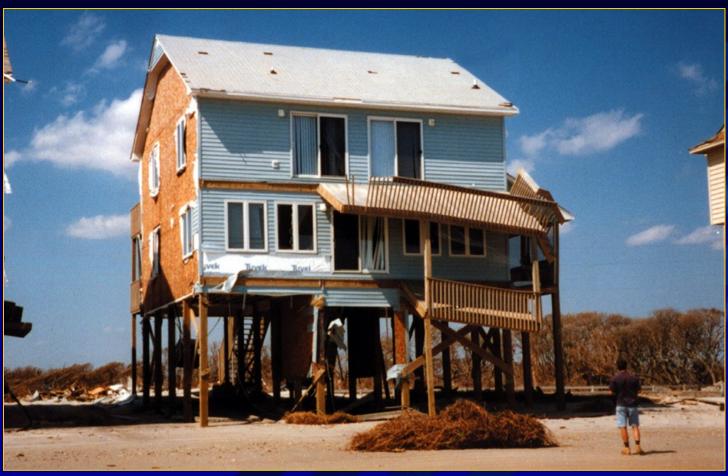
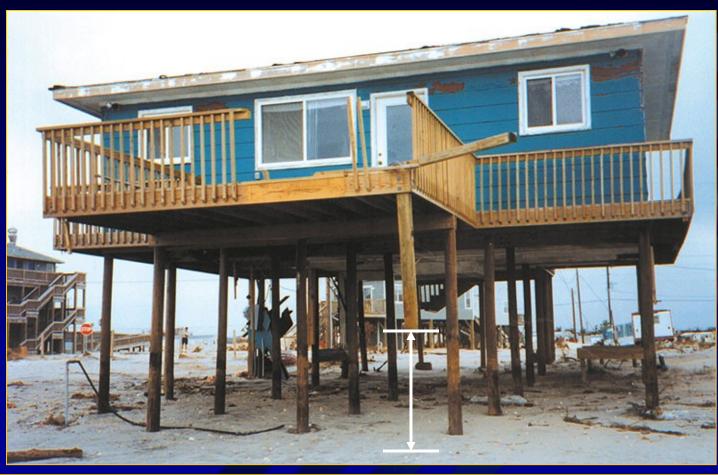
- Piling and Post Embedment Depths
 - Shallow embedment depths on pre-1986 buildings
 - Shallow embedment depths on decks, porches, and roof overhangs on pre-1986 and post-1985 buildings
 - Shallow post embedment depths for AC/ heat pump compressor platforms

- Piling and Post Embedment Depths
 - In absence of State/local requirements, embedment depth for pilings in erosion-prone areas should be -10 feet m.s.l.
 - State of North Carolina should consider requiring embedment of 16 feet below grade or 5 feet m.s.l., whichever is deeper
 - Embedment depths for deck, porch, and roof overhang pilings should be same as for main building

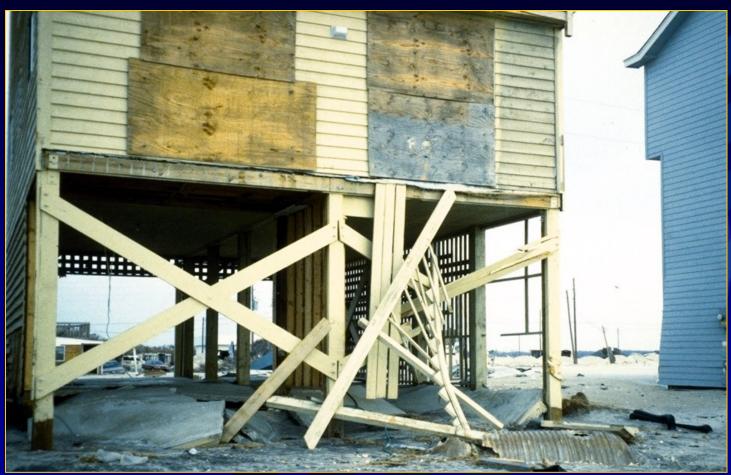
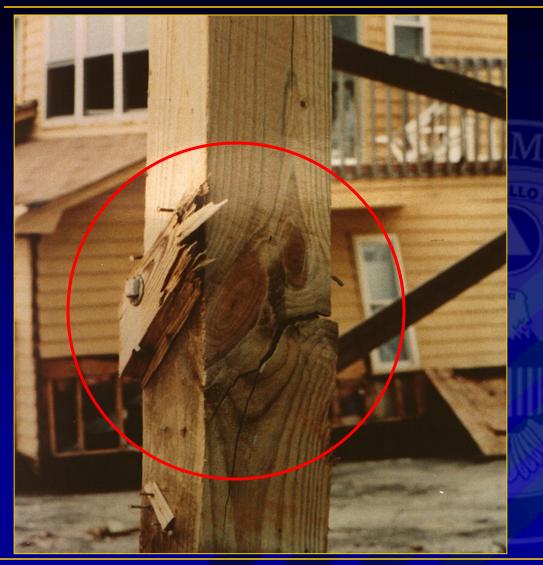
- Use of Cross-Bracing
 - Installed perpendicular to velocity flow and wave action
- Grade of Lumber for Pilings and Cross-Bracing
 - Use of lumber with excessive numbers of knots, cracks, or other defects for vertical foundation members and cross-bracing

- State and Local Requirements
 - Consider adding code requirements regarding grade of lumber used for pilings and cross-bracing
 - Consider requiring that buildings be elevated <u>above</u> the BFE

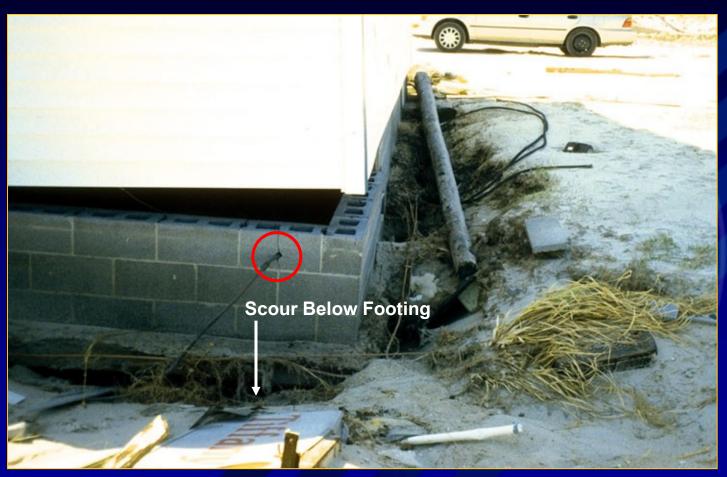
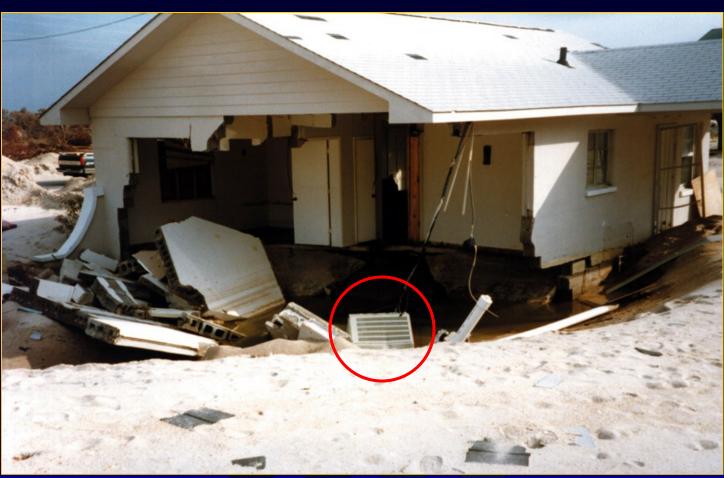
- Continuous Foundation Walls
 - Use in A-zone areas susceptible to high velocity flow

- Other Foundation Issues
 - Design foundations to resist flood/wind forces without cross-bracing
 - Require engineering analysis of potential scour before permitting solid foundation walls in landward areas subject to highvelocity flow

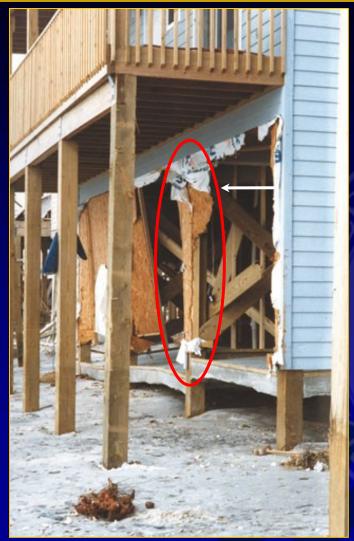
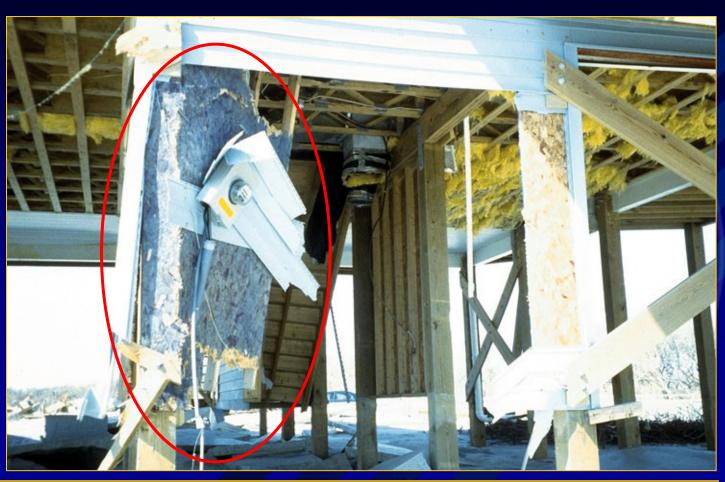
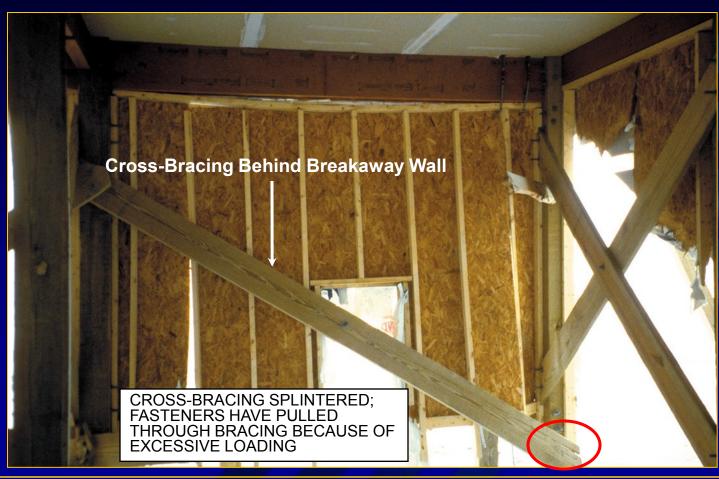
- Breakaway Walls
 - Placement seaward of cross-bracing
 - Installation of sheathing continuously across vertical foundation members
 - Attachment methods that prevented breakaway (e.g., too many fasteners)

- Breakaway Walls
 - Do not extend sheathing across vertical foundation members
 - Attach walls so that they will break away under flood forces
 - Do not install walls immediately seaward of cross-bracing

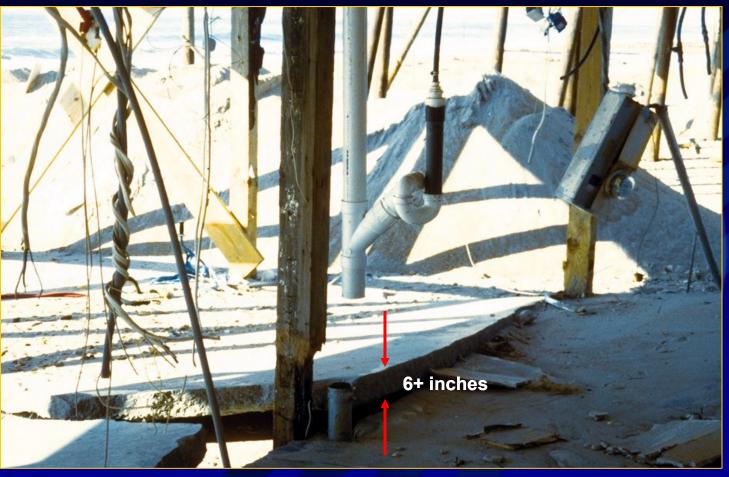
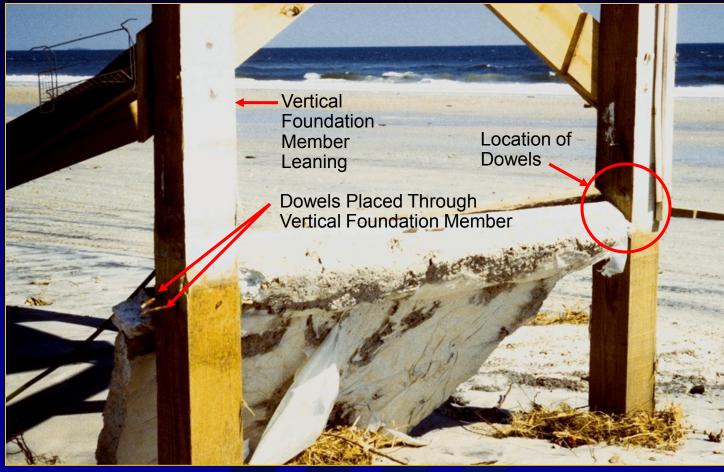
- Below-Building Concrete Slabs
 - Slabs too thick (i.e., >4 inches)
 - Inadequate number of contraction joints
 - Use of wire mesh in slabs
 - Slabs connected to vertical foundation members

- Below-Building Slabs
 - Limit slab thickness to 4 inches
 - Install adequate number of contraction joints
 - Do not use wire mesh

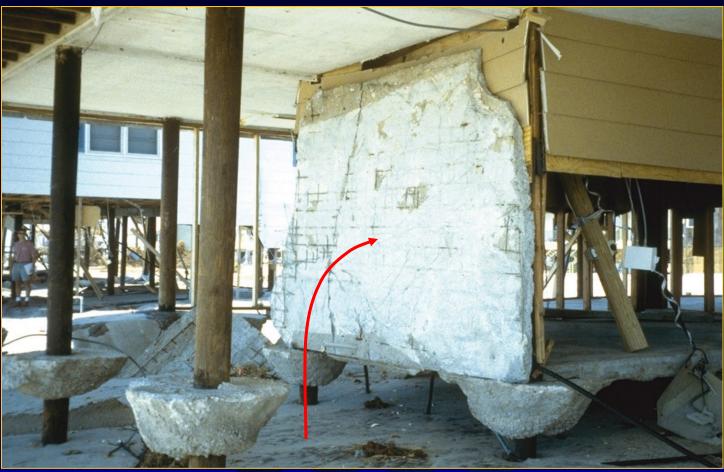
- Below Building Concrete Slabs (continued)
 - Slabs and grade beams cast monolithically
 - Use of concrete collars around vertical foundation members to support slabs

- Below-Building Slabs (continued)
 - Do not connect slabs to vertical foundation members
 - Do not cast slabs/grade beams monolithically
 - Do not install concrete collars around vertical members under slabs

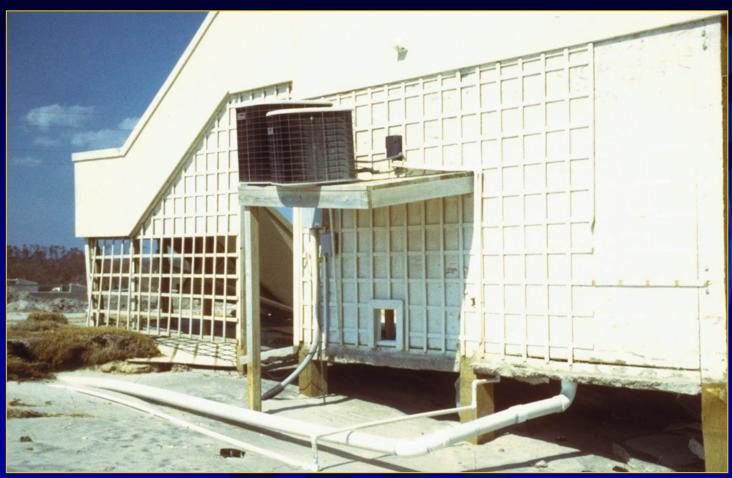
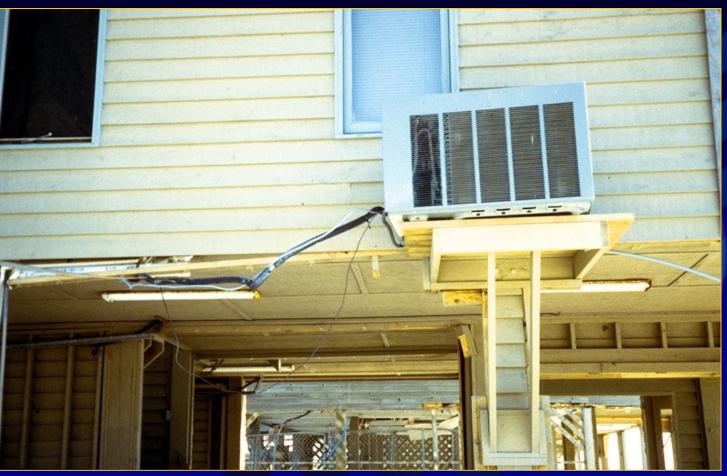
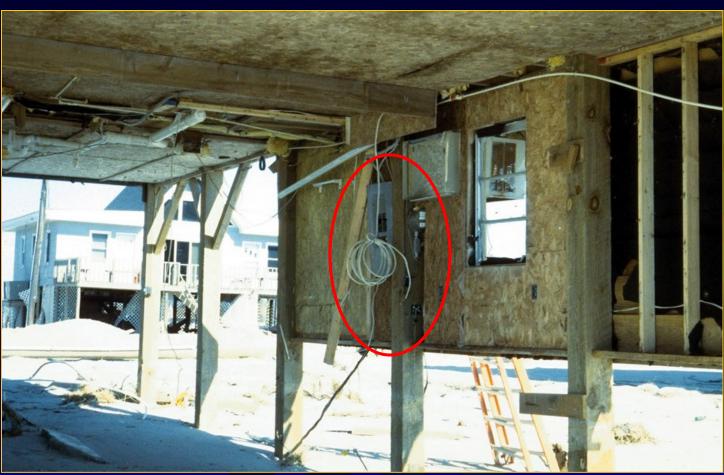
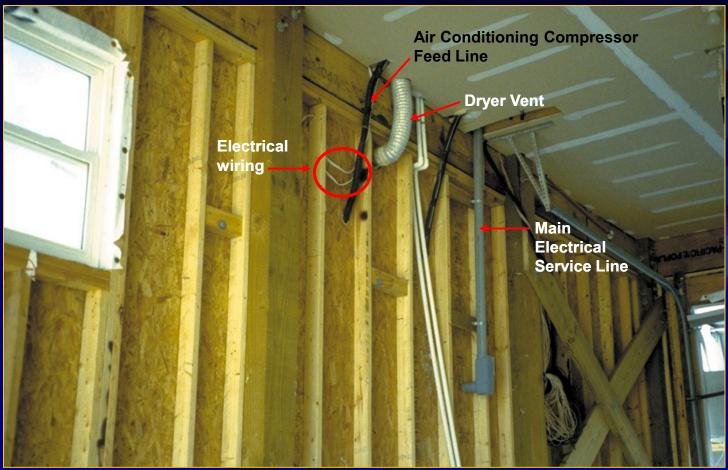
- On-Site Utility Systems
 - AC/heat pump compressor platform support posts not embedded deep enough
 - Unanchored AC/heat pump compressors
 - System components on or adjacent to breakaway walls

- On-Site Utility Systems
 - Embed vertical members for AC/heat pump compressor platform to same depth as those for main building, or use cantilever platform
 - Anchor compressor to resist wind

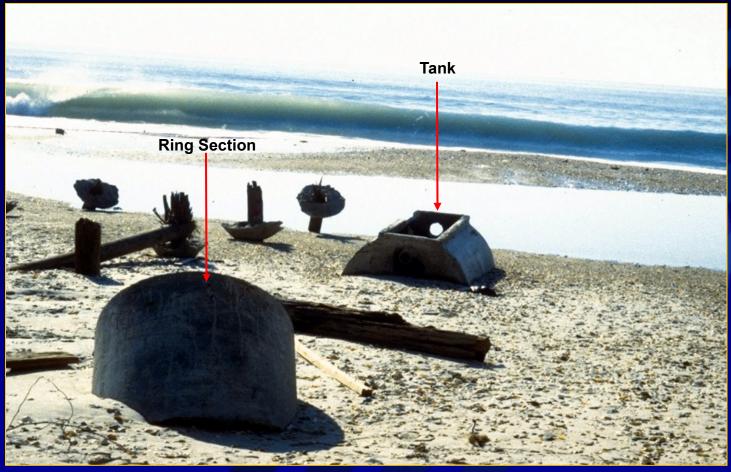
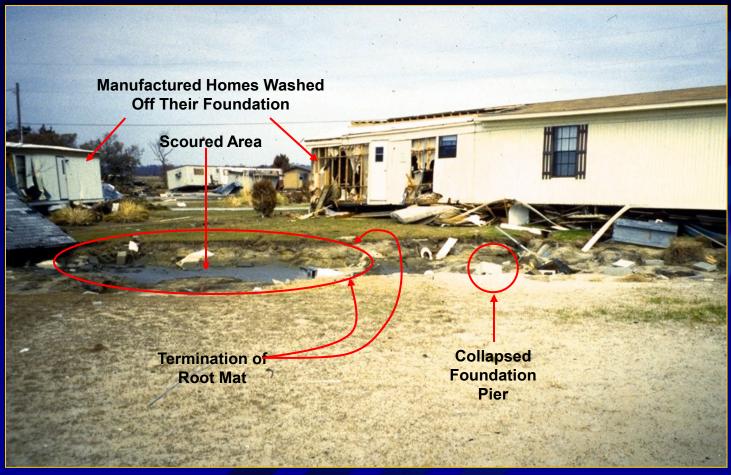
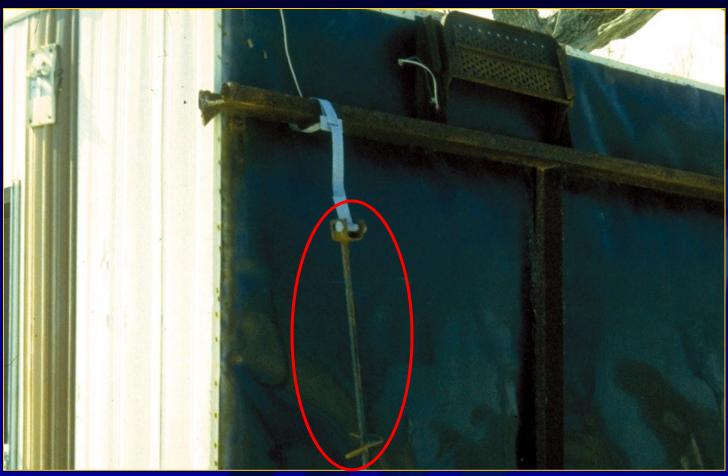
- On-Site Utility Systems (continued)
 - System components installed on seaward faces of vertical foundation members nearest ocean
 - Septic tanks installed on ocean side of building

- On-Site Utility Systems (continued)
 - Do not place utility system components on, through, or adjacent to breakaway wall panels
 - Locate utility system components on landward faces of vertical foundation members farthest from ocean
 - Locate septic tanks as far landward as possible

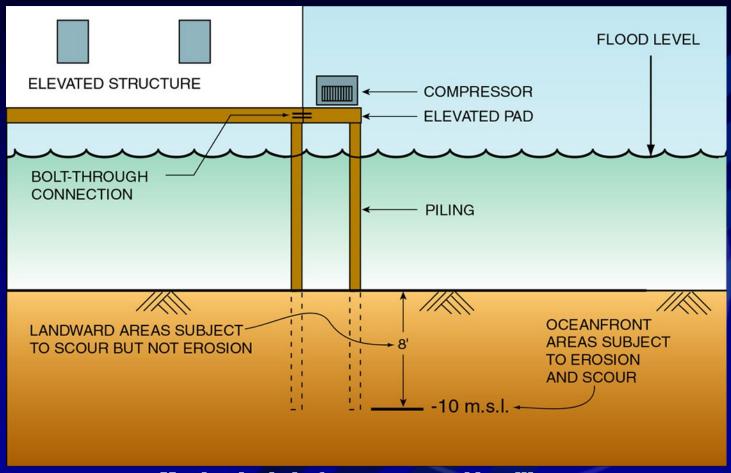
Mechanical platform supported by pilings.
